Figure H-1. Compaction Testing Locations

Source: Final Pole Canyon Non-Time Critical Removal Action Construction Inspection Report (Formation 2017b).

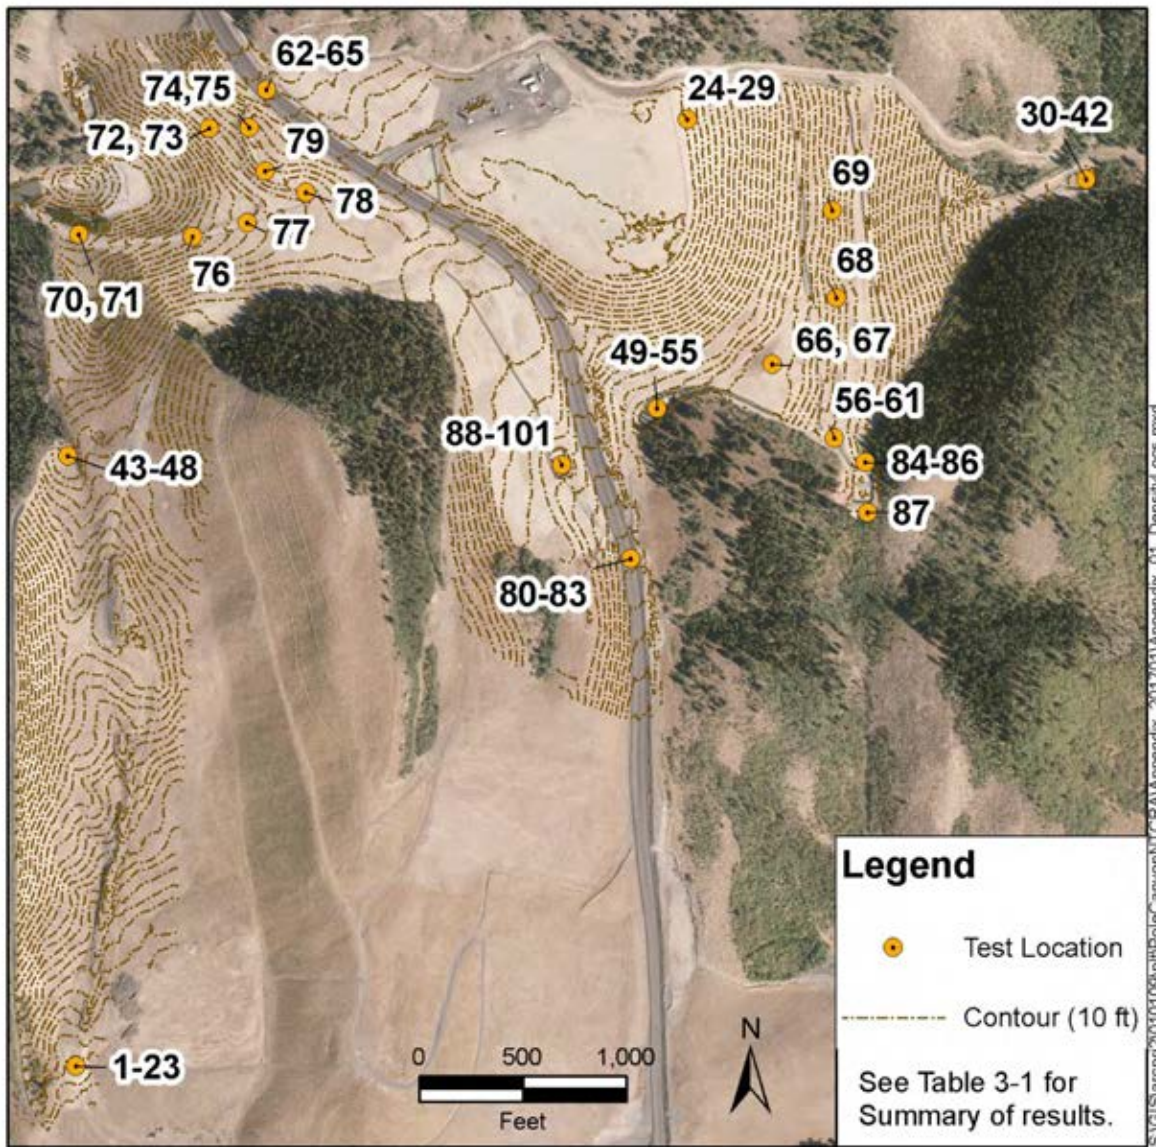
The compaction requirement is equal to or greater than 95 percent of the maximum dry density (specification 02200 Paragraph 3.4 C).

Locations of density testing are shown in Figure H-1.

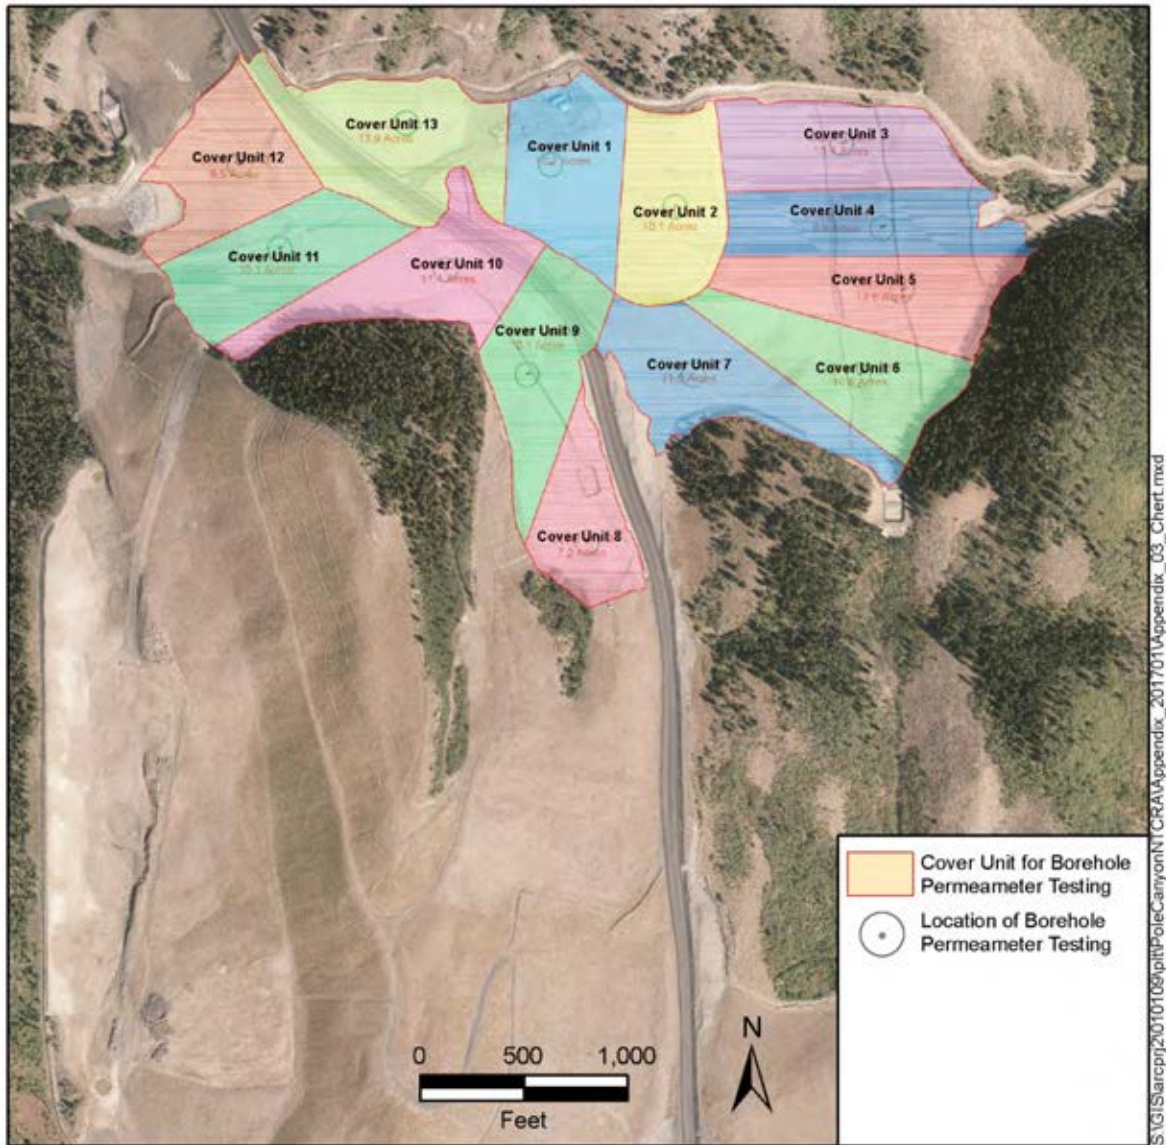
Figure H-3. Field Permeability (Borehole Permeameter) Testing Locations

The performance standard for the Pole ODA cover system is  $1 \times 10^{-4}$  cm/sec (Appendix D of the Construction Inspection Report).

Locations of borehole permeameter testing are shown in Figure H-3.
